#### **C-thrue** Dual-polarized, high-frequency GPR

#### **Concrete Bridges Investigation**

#### **On-site results** Case Studies

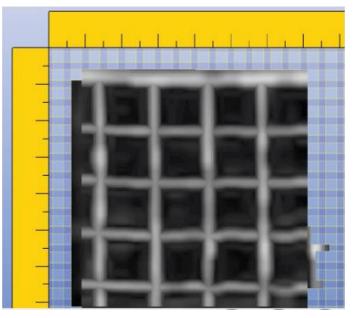
Standard GPR visualisation Rebar mesh

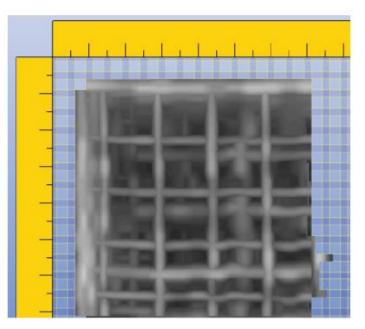
C-thrue visualisation Dual antenna polarisation allows the optimal detection of both first and deeper levels of objects

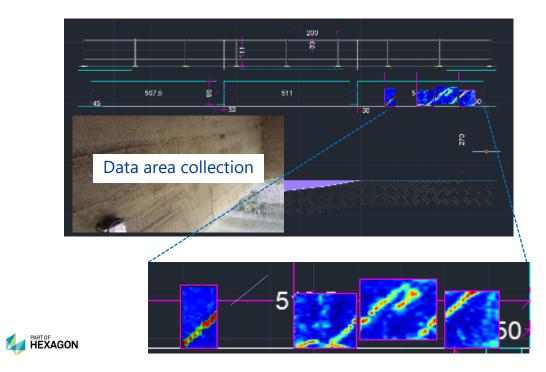
#### **Case Study 4** Bridge on the Orme river (Empoli)

#### Reinforcement bars located with the GPR

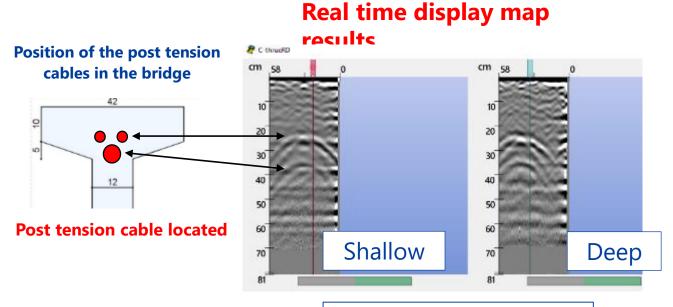
#### Locating post-tension cables

The VV channel (deep) confirm the HH visualization (shallow)

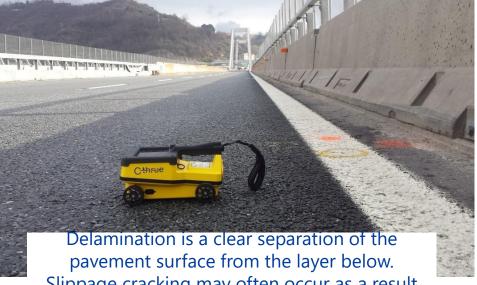
#### **Asphalt delamination**

pavement surface from the layer below. Slippage cracking may often occur as a result of poor adhesion between shallow and deep layers

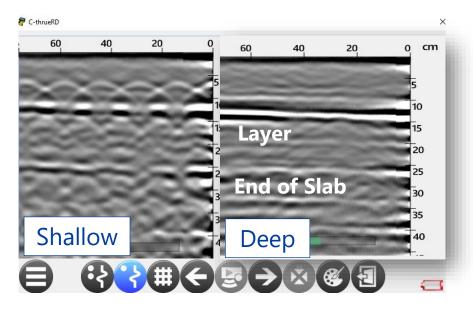
#### Locating voids - Slab thickness

**C-thrue data display**
